Geotechnical Investigation Report

Proposed Multi-Family Residential Development on ± 0.16 Acres
APN 160-02-068 and a Portion of APN 160-02-067
8916 North 11th Street
Phoenix, Arizona 85020

May 7, 2021

Project 28429

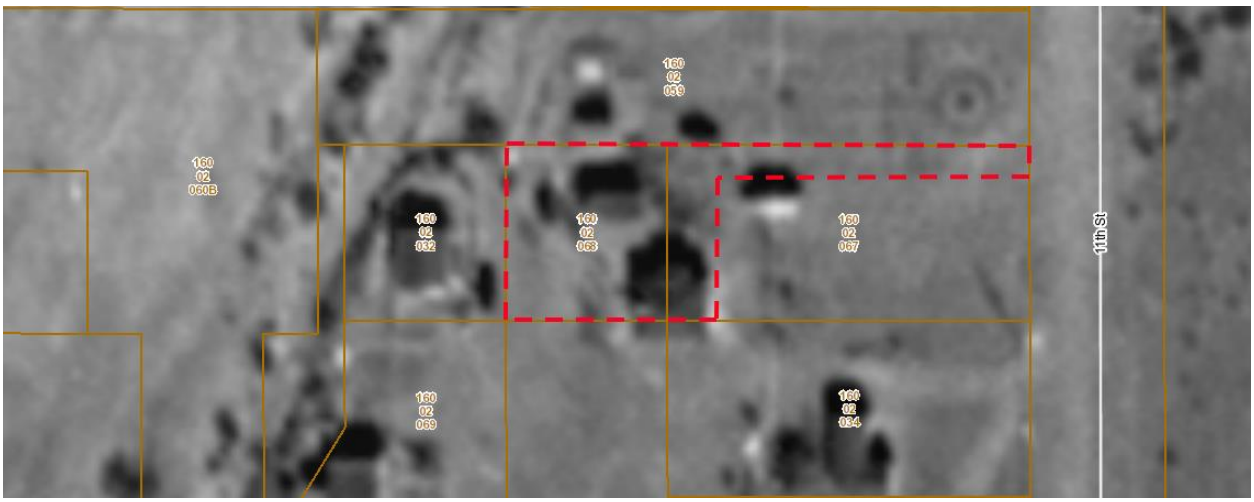
Figure 2: 1949 historical aerial photograph showing development on the site

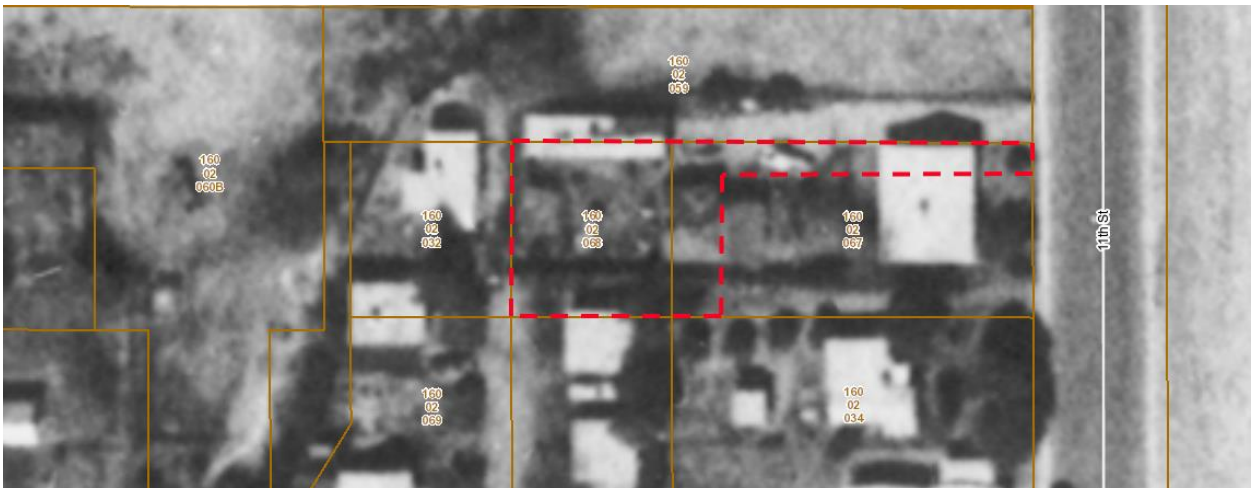
Figure 3: 1976 historical aerial photograph showing additional development on the site

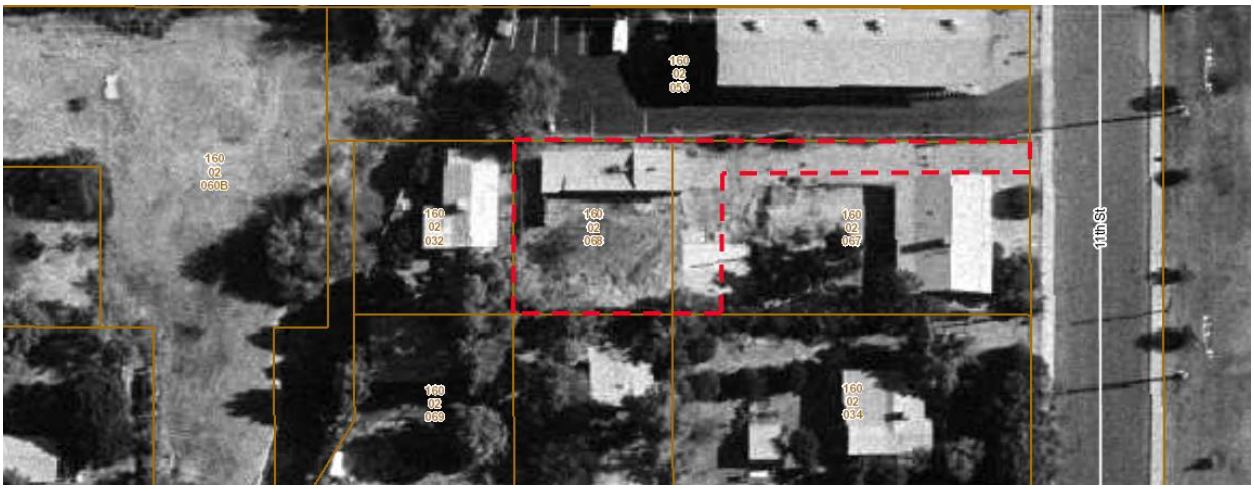
Figure 4: 1982 historical aerial photograph showing that the structure at the south-central portion of the site had been demolished except the concrete slab
